ATS or BD.....you decide.

The products that I'll be discussing are two competing sets of compound turbos, both installed on 2006 Dodge Ram's with Cummins Turbo Diesel engines. One set was from ATS, which included the Aurora 3000 and Aurora 5000 turbos and the other was from BD Power, which included the SuperB and R700 turbos. Both are advertised as towing / race setups.

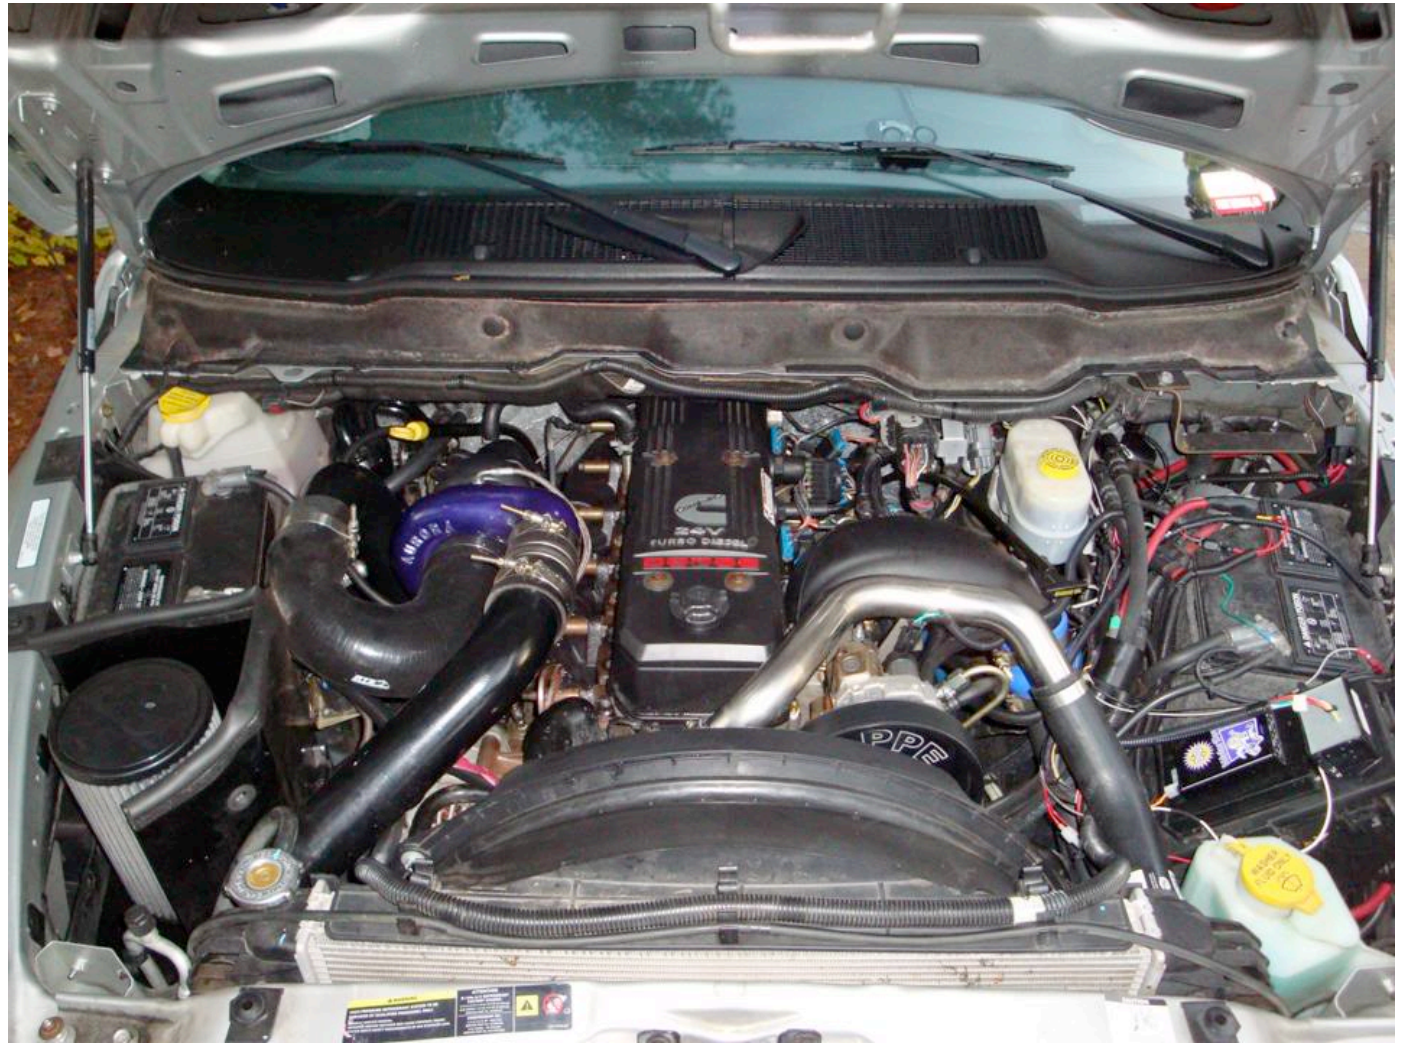
ATS Aurora Compounds on the silver 2500:

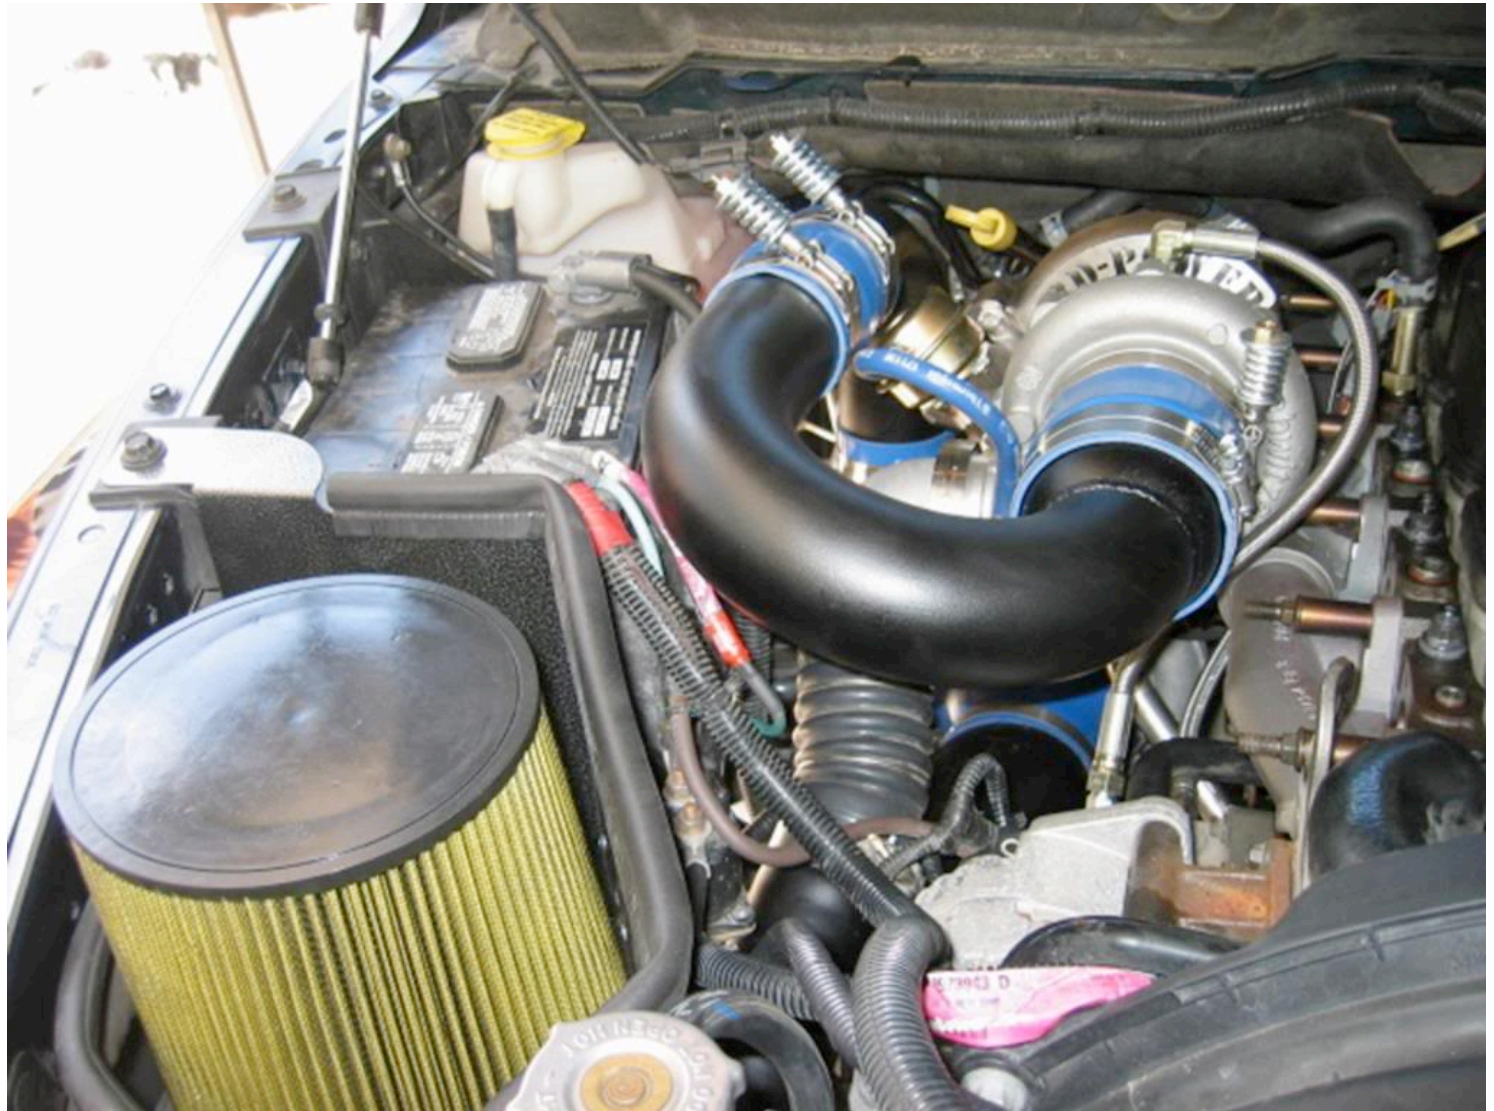
BD Power R700 Compounds on the blue 3500:

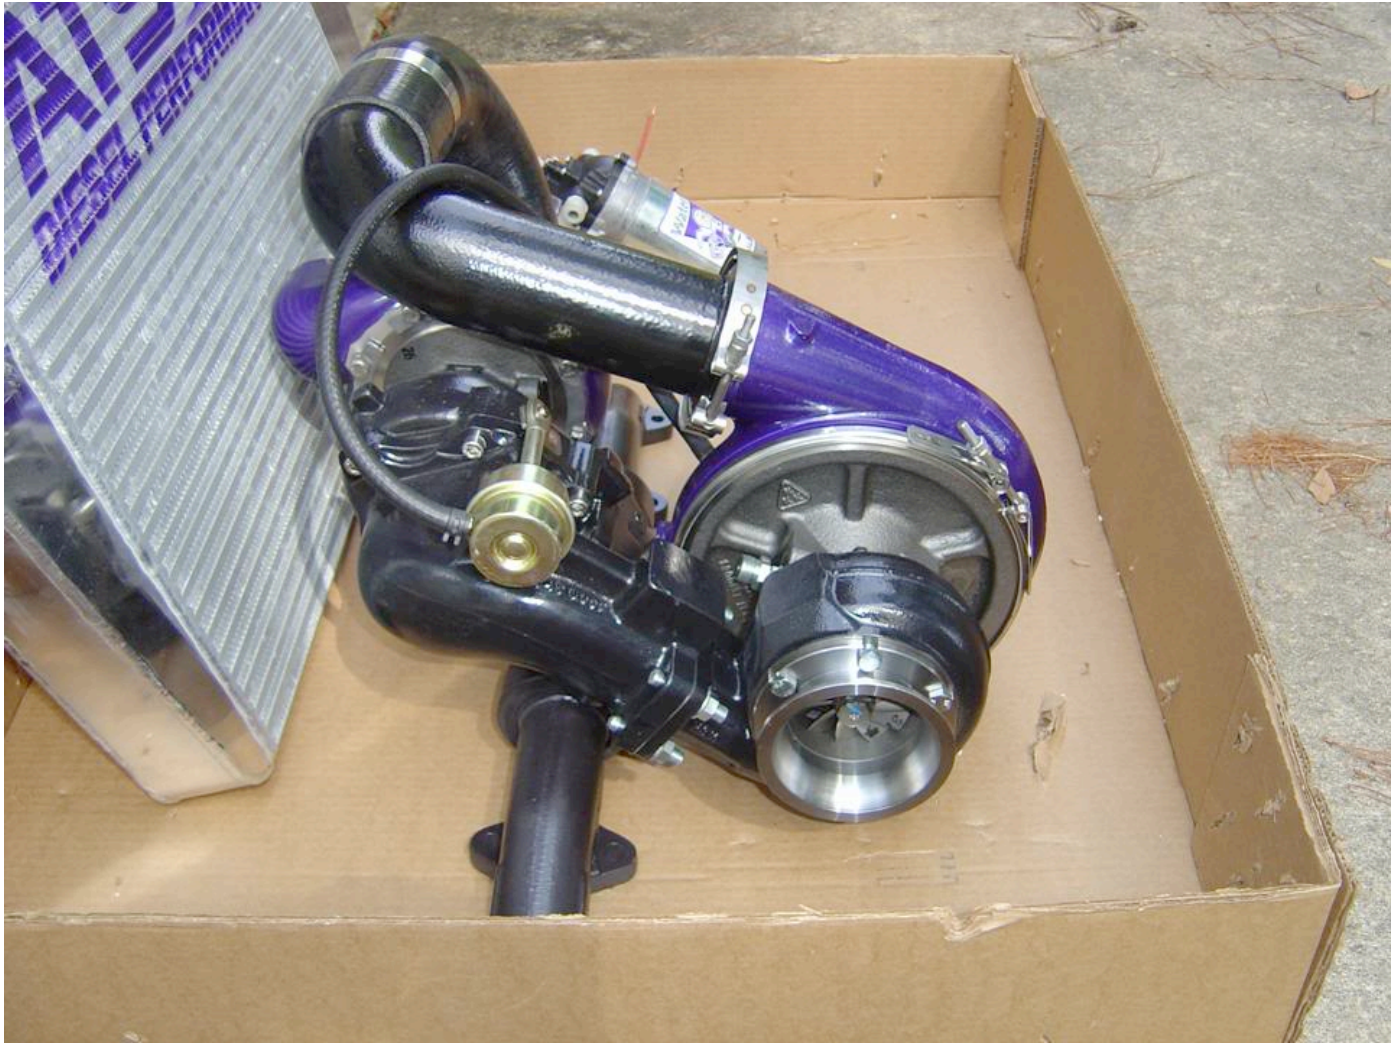
When the parts arrived, they were in very different conditions from each other. The ATS kit came completely assembled and made for a very easy install. You had the finished product to look at prior to installation.

The parts arrived complete, free of rust and corrosion and clocked correctly for the application.

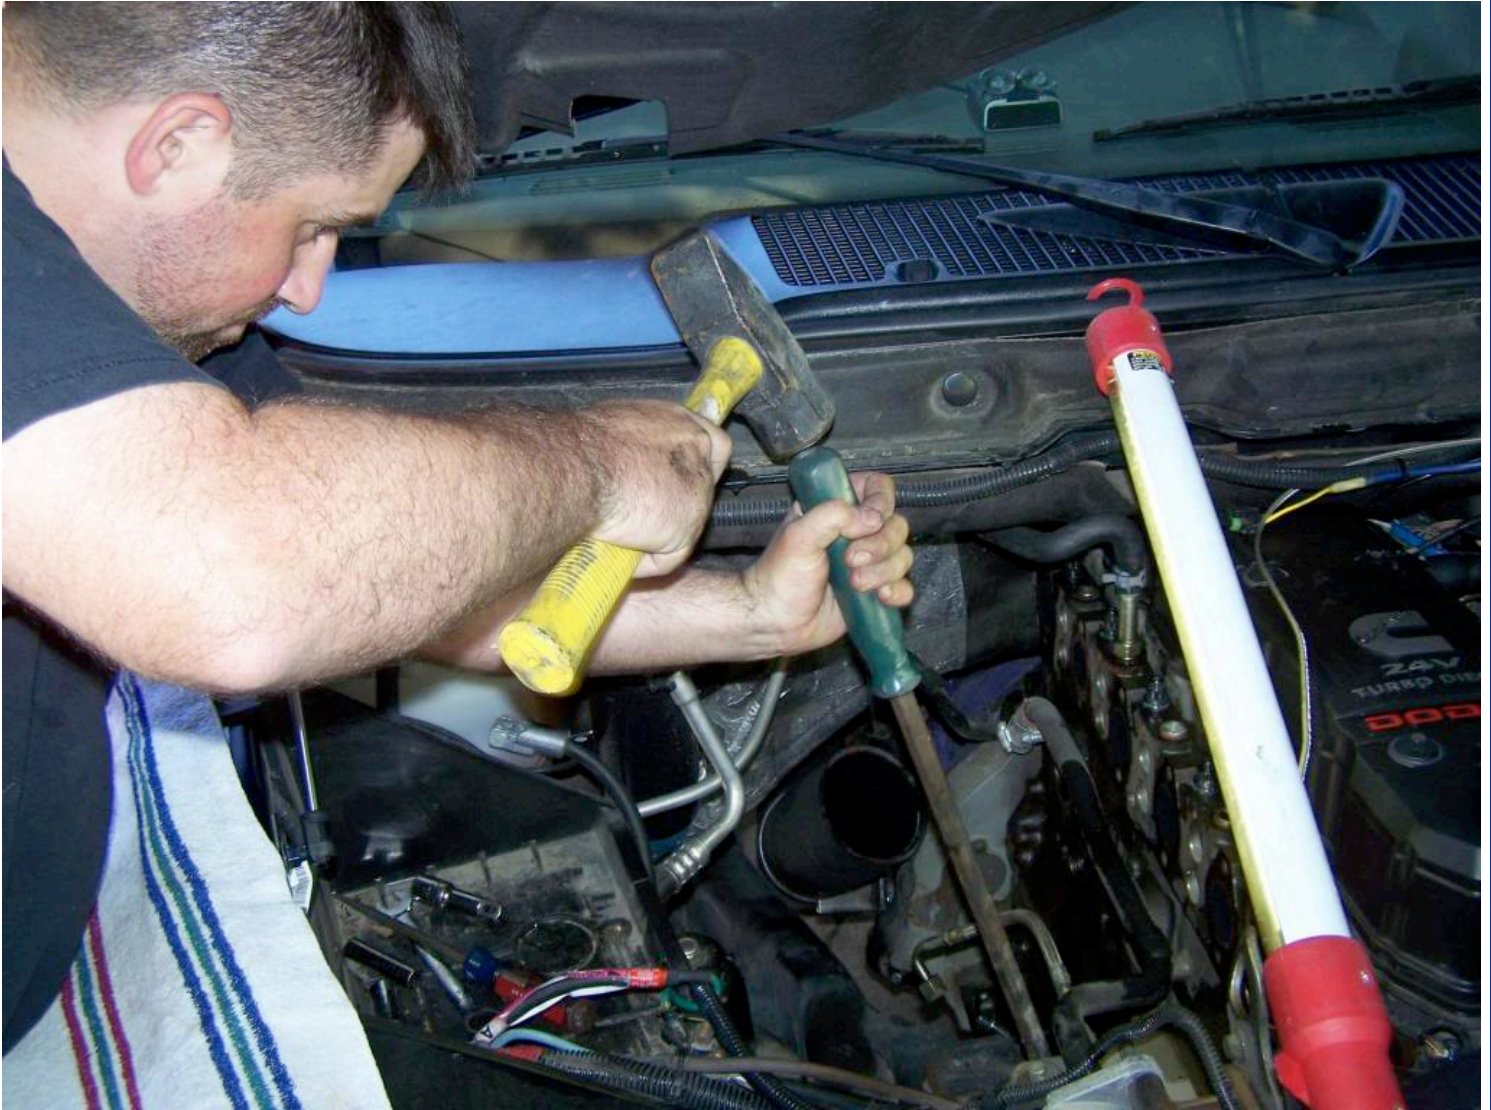
The secondary turbo also required a steel adapter to go in the frost plug hole. This adapter did not fit. The instructions said that you may have to use a punch to get it to fit....this was a mild understatement.

I tried brass and steel punches, using a reasonable amount of force and it would not even seat. I ended up need to use a pry bar and a mallet to mark the adapter where it was oversized so it could be re-sized with a die grinder.

Once it was chamfered and resized, the secondary adapter was installed. The picture below is of those two components and their associated hoses and clamps installed.

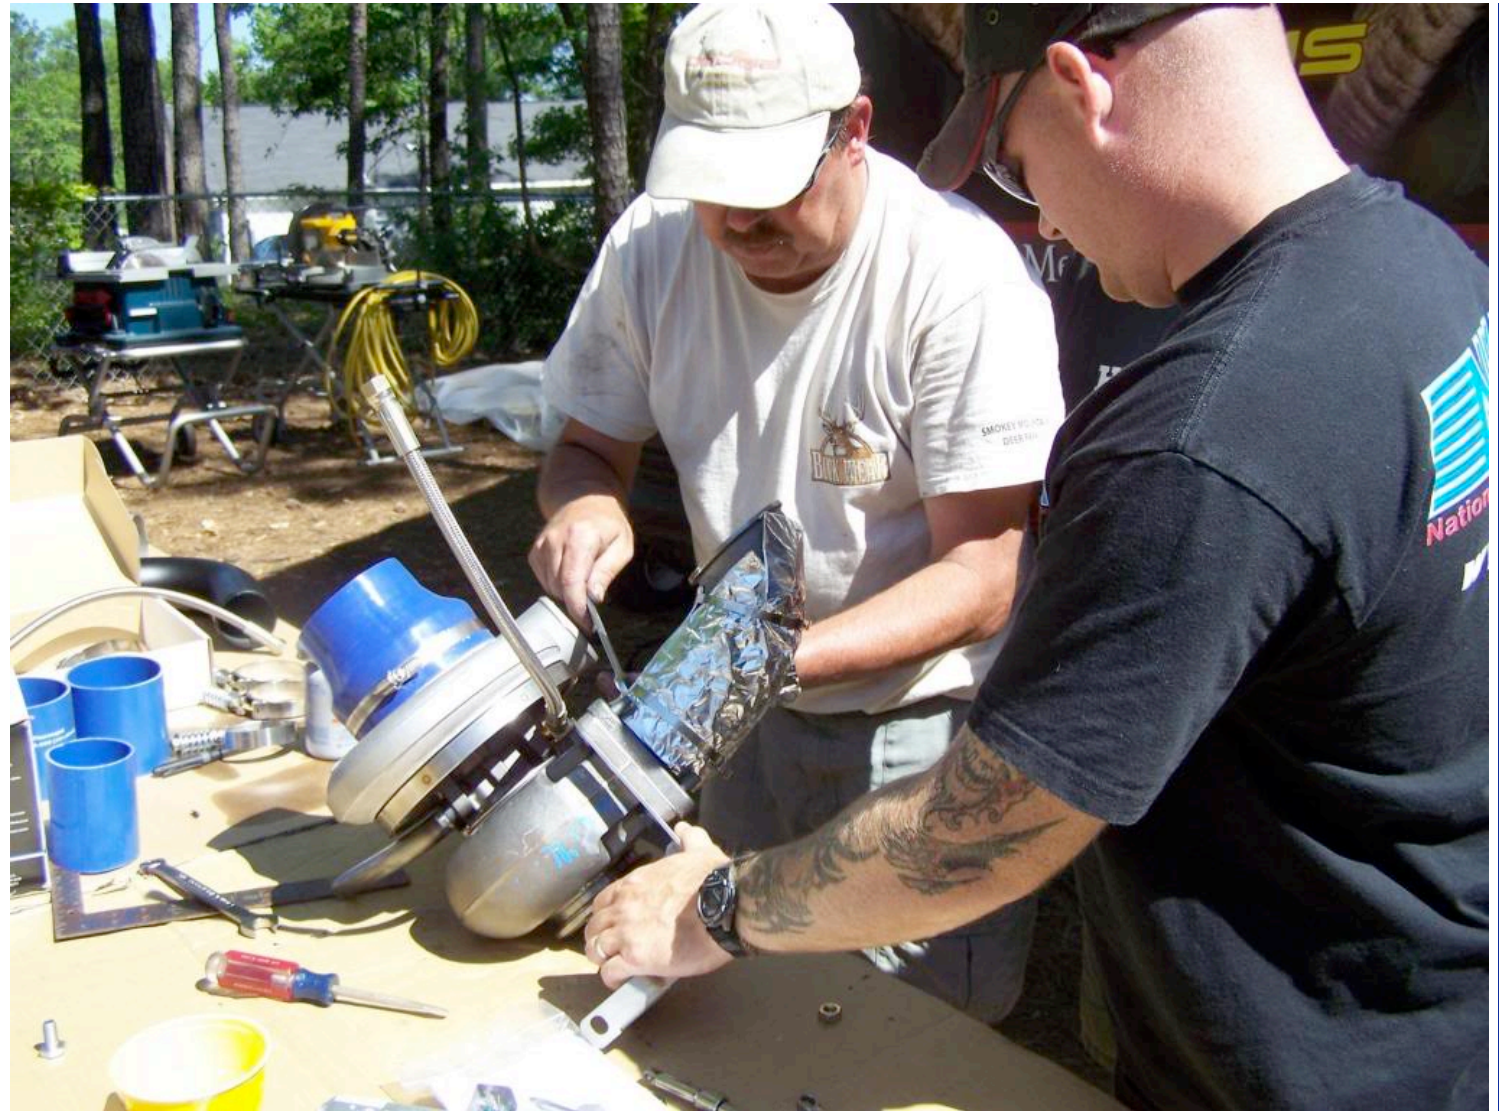
From here, you must fit the exhaust adapter from the secondary to the primary on the BD compound. This again presented a problem. The studs supplied with the kit were incorrect in thread pitch, count and coarseness. We had to run to the hardware store to get fasteners of the correct type to bolt the adapter to the primary.

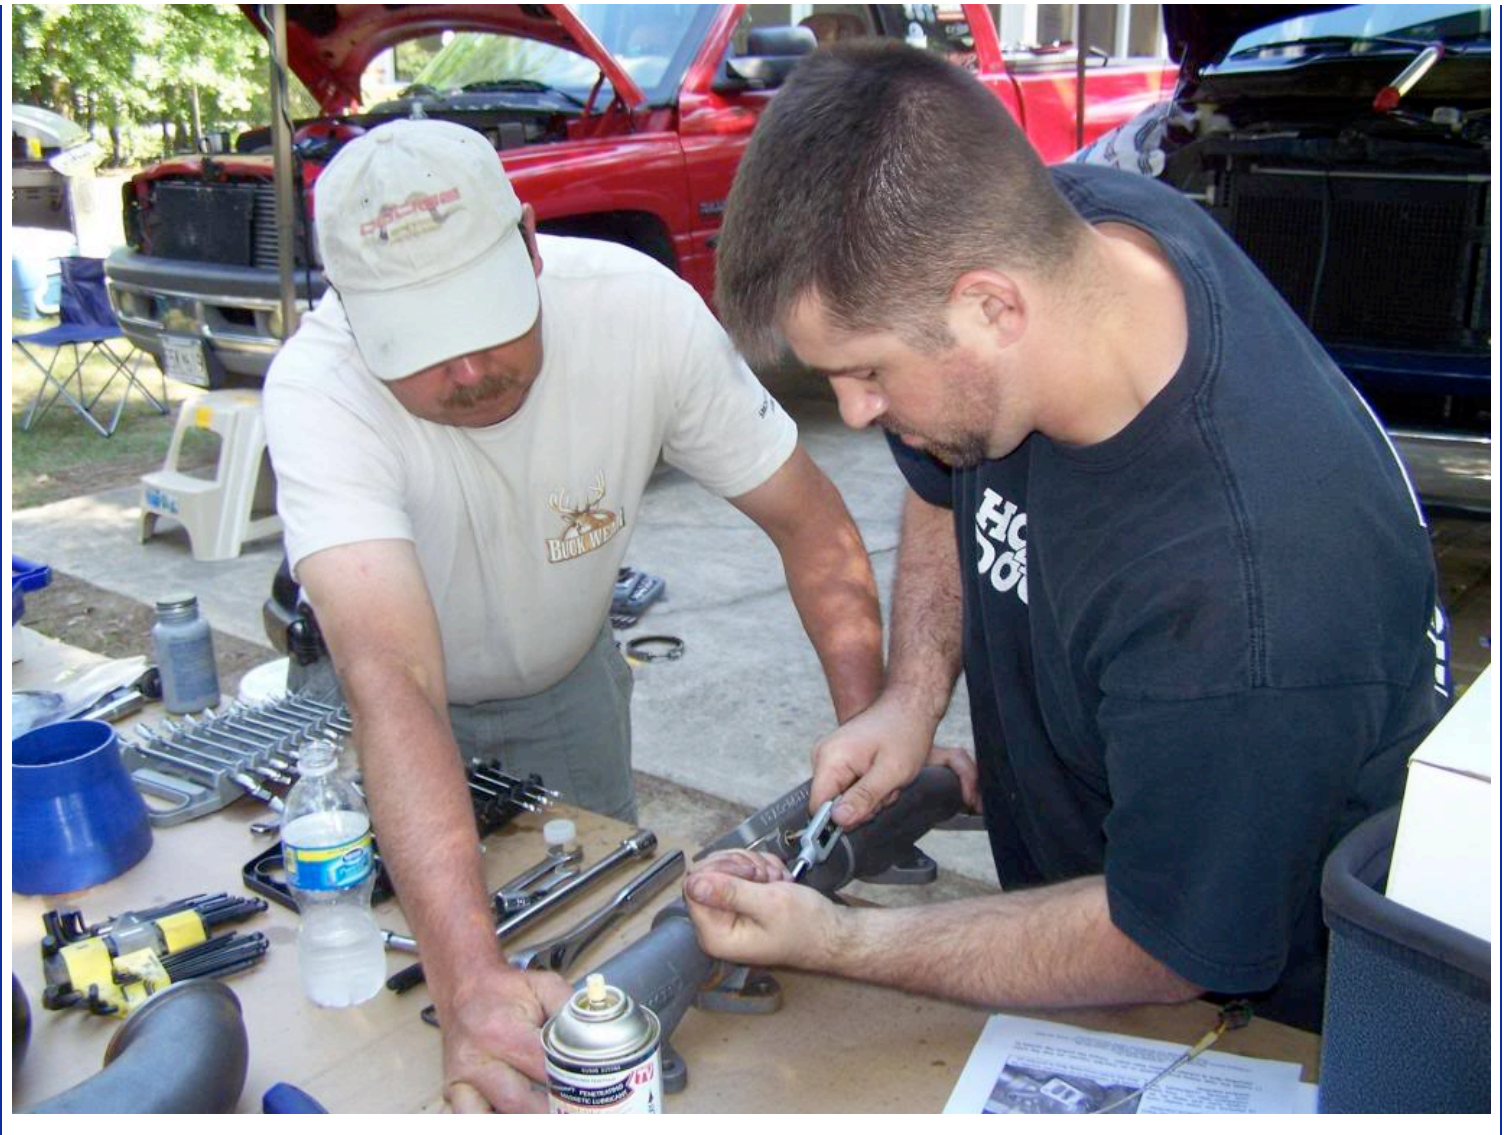
The BD kit came with two pre-drilled and tapped ports. The ports, as the manifold was to be installed, were located on the bottom of the manifold. They were also not tapped deep enough to properly seat a 1/8 NPT fitting. We could only get 2 threads of the probe fitting in before it stopped. This required tapping the manifold further to allow proper EGT probe function.

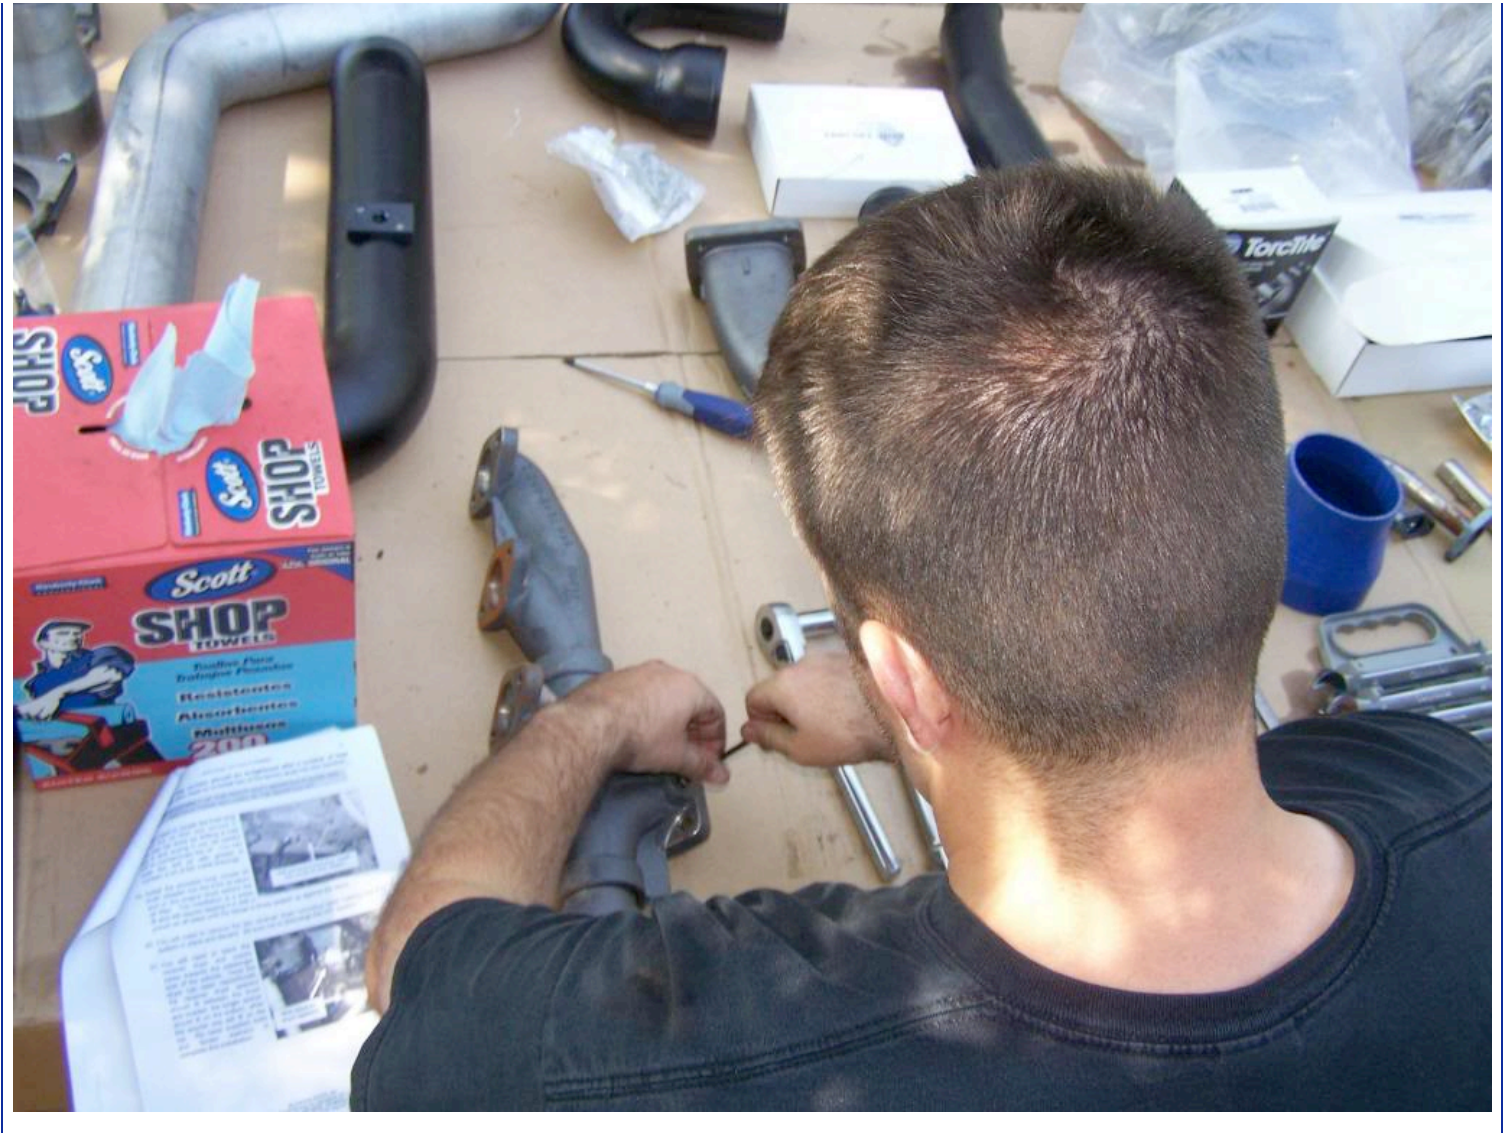
Once this was done, we installed the EGT probes and found another problem. The location of the ports on the bottom of the BD manifold did not allow enough clearance for straight type EGT probes. The probes ran directly into the side of the SuperB compressor housing. We ended up taking two 90* probes off of another truck to make them fit.

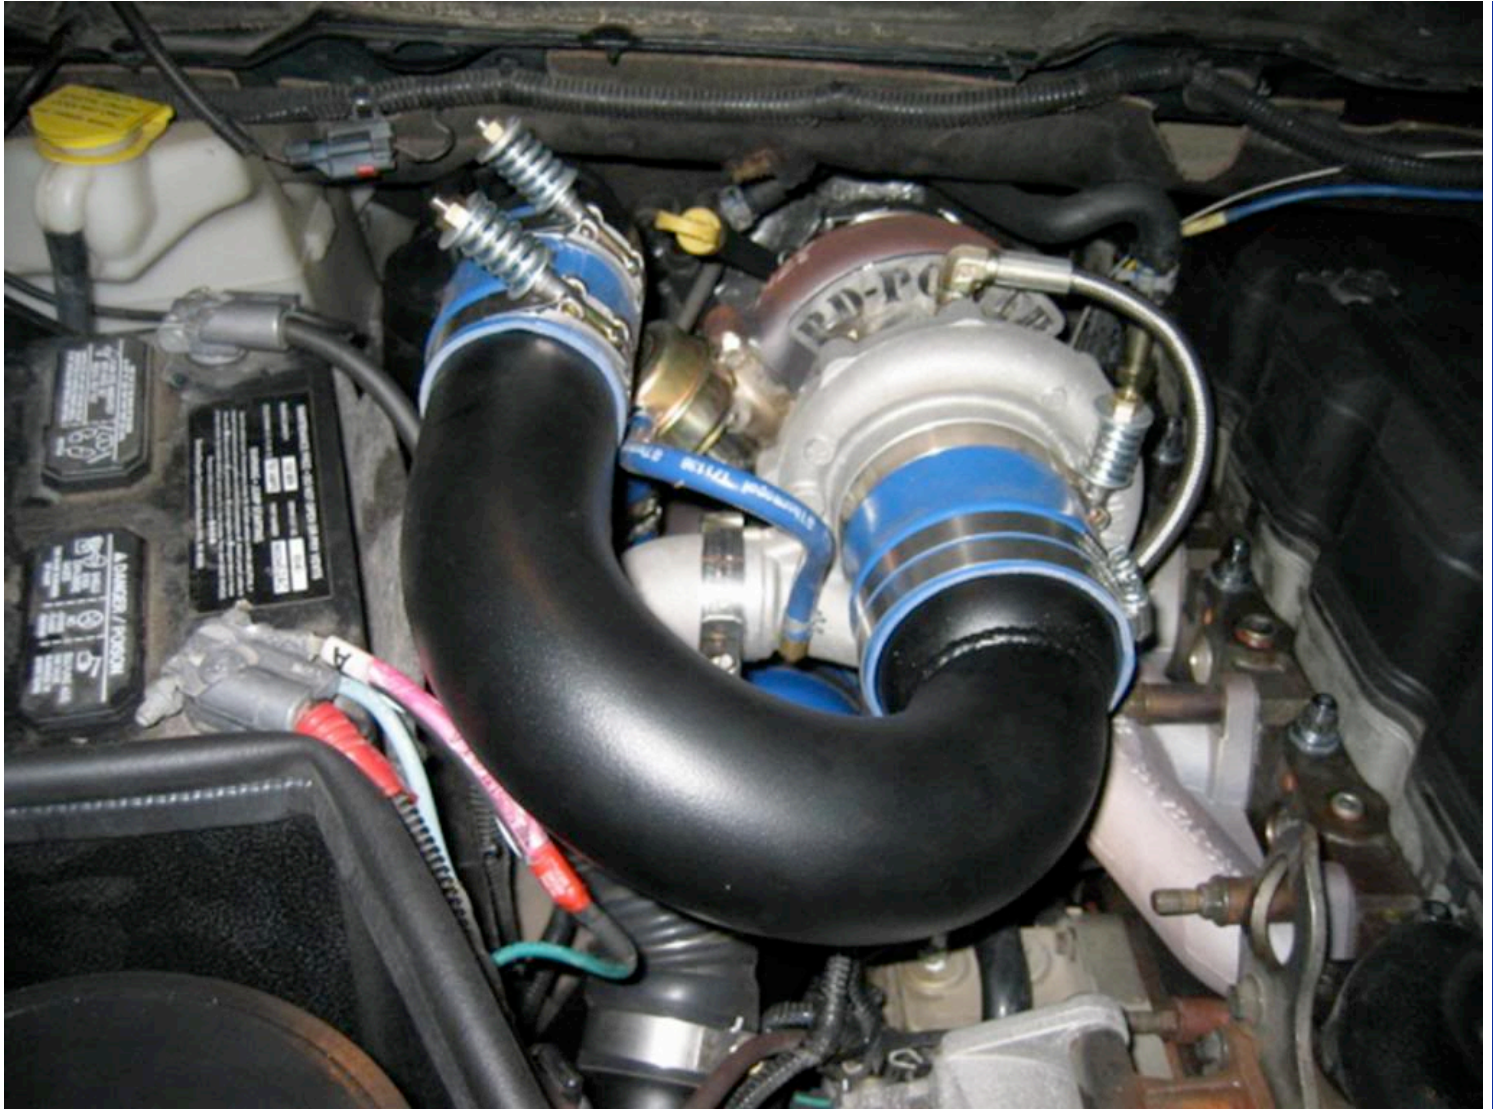
The BD kit called for new cap head bolts all the way around. These were supposed to be included in the kit, but were not, so the OEM studs were re-used. This caused another trip to the hardware store for cap head bolts to fit behind the manifold.

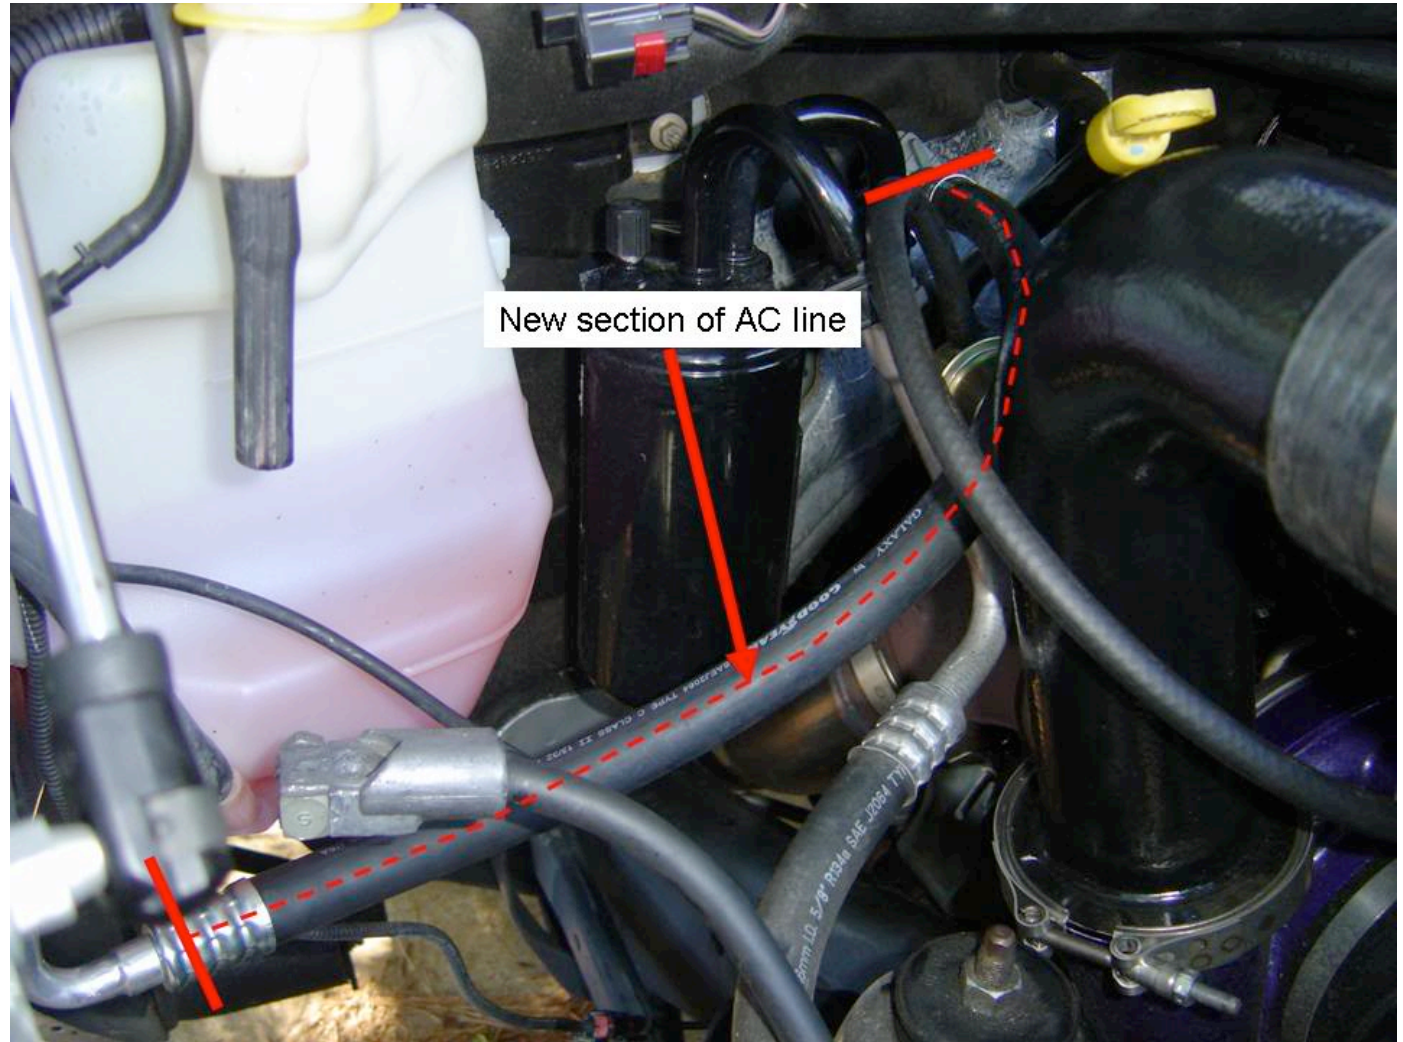
Now this is where we ran into a problem with the ATS setup. The location of the wastegate head was trying to occupy the same space as one of the AC lines. This required evacuating the AC system and removing the AC line until I could get a custom one made at a local shop. Here is the line I had to remove and the one I had had made to clear the wastegate head.

I contacted ATS regarding this, sent them the pictures and was reimbursed the \$45 that it cost me to have a new AC line made.

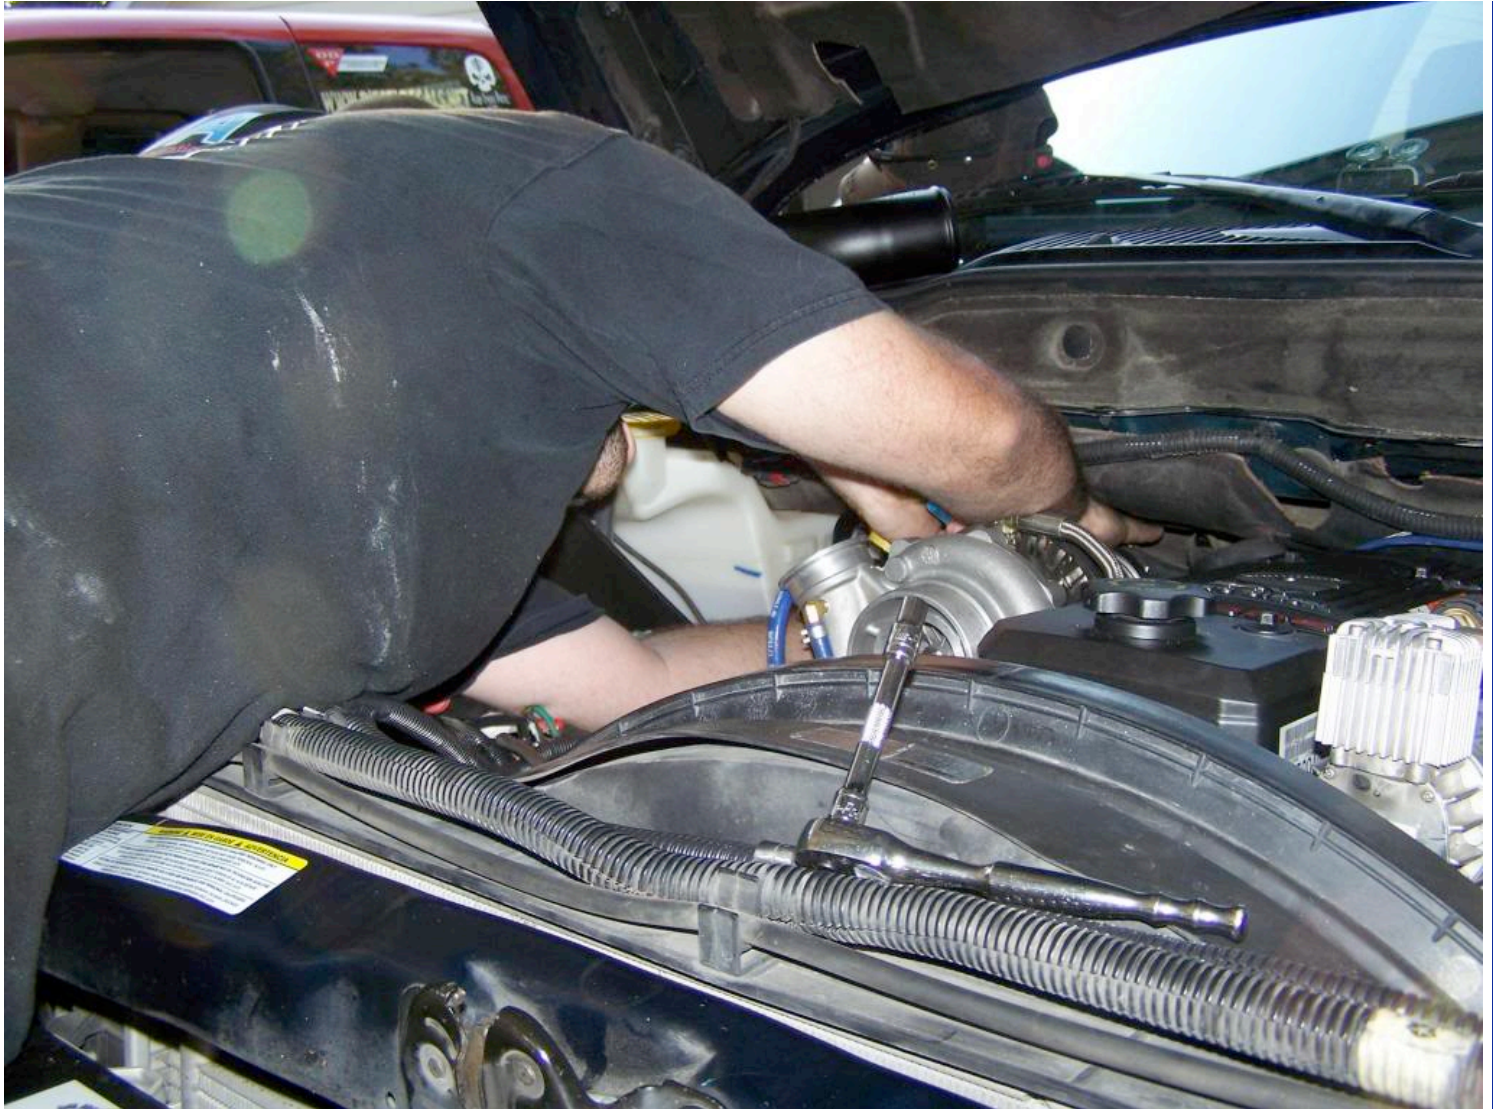
As we began routing the piping, we found that the compressor outlets still needed some tweaking to line up. Other than it being a pain to reach all the hold down bolts at this point, we found that the location of the wastegate head made it impossible to turn the compressor outlet to the correct position. You could go toward the engine, as it would hit the manifold and you couldn't go toward the battery as you hit the wastegate head. So, we had to remove the wastegate head, clock the compressor housing and then re-install the head. Now, the location to the wastegate head and it's 3 bolts make this a task for a contortionist. This took us a little while and increased our vulgarities count significantly.
